REPORT OF WATER QUALITY IN MACLEAN LAKE SIMCOE CO.

Ministry
of the
Environment

RECREATIONAL LAKES PROGRAM

1973 WATER QUALITY SURVEY

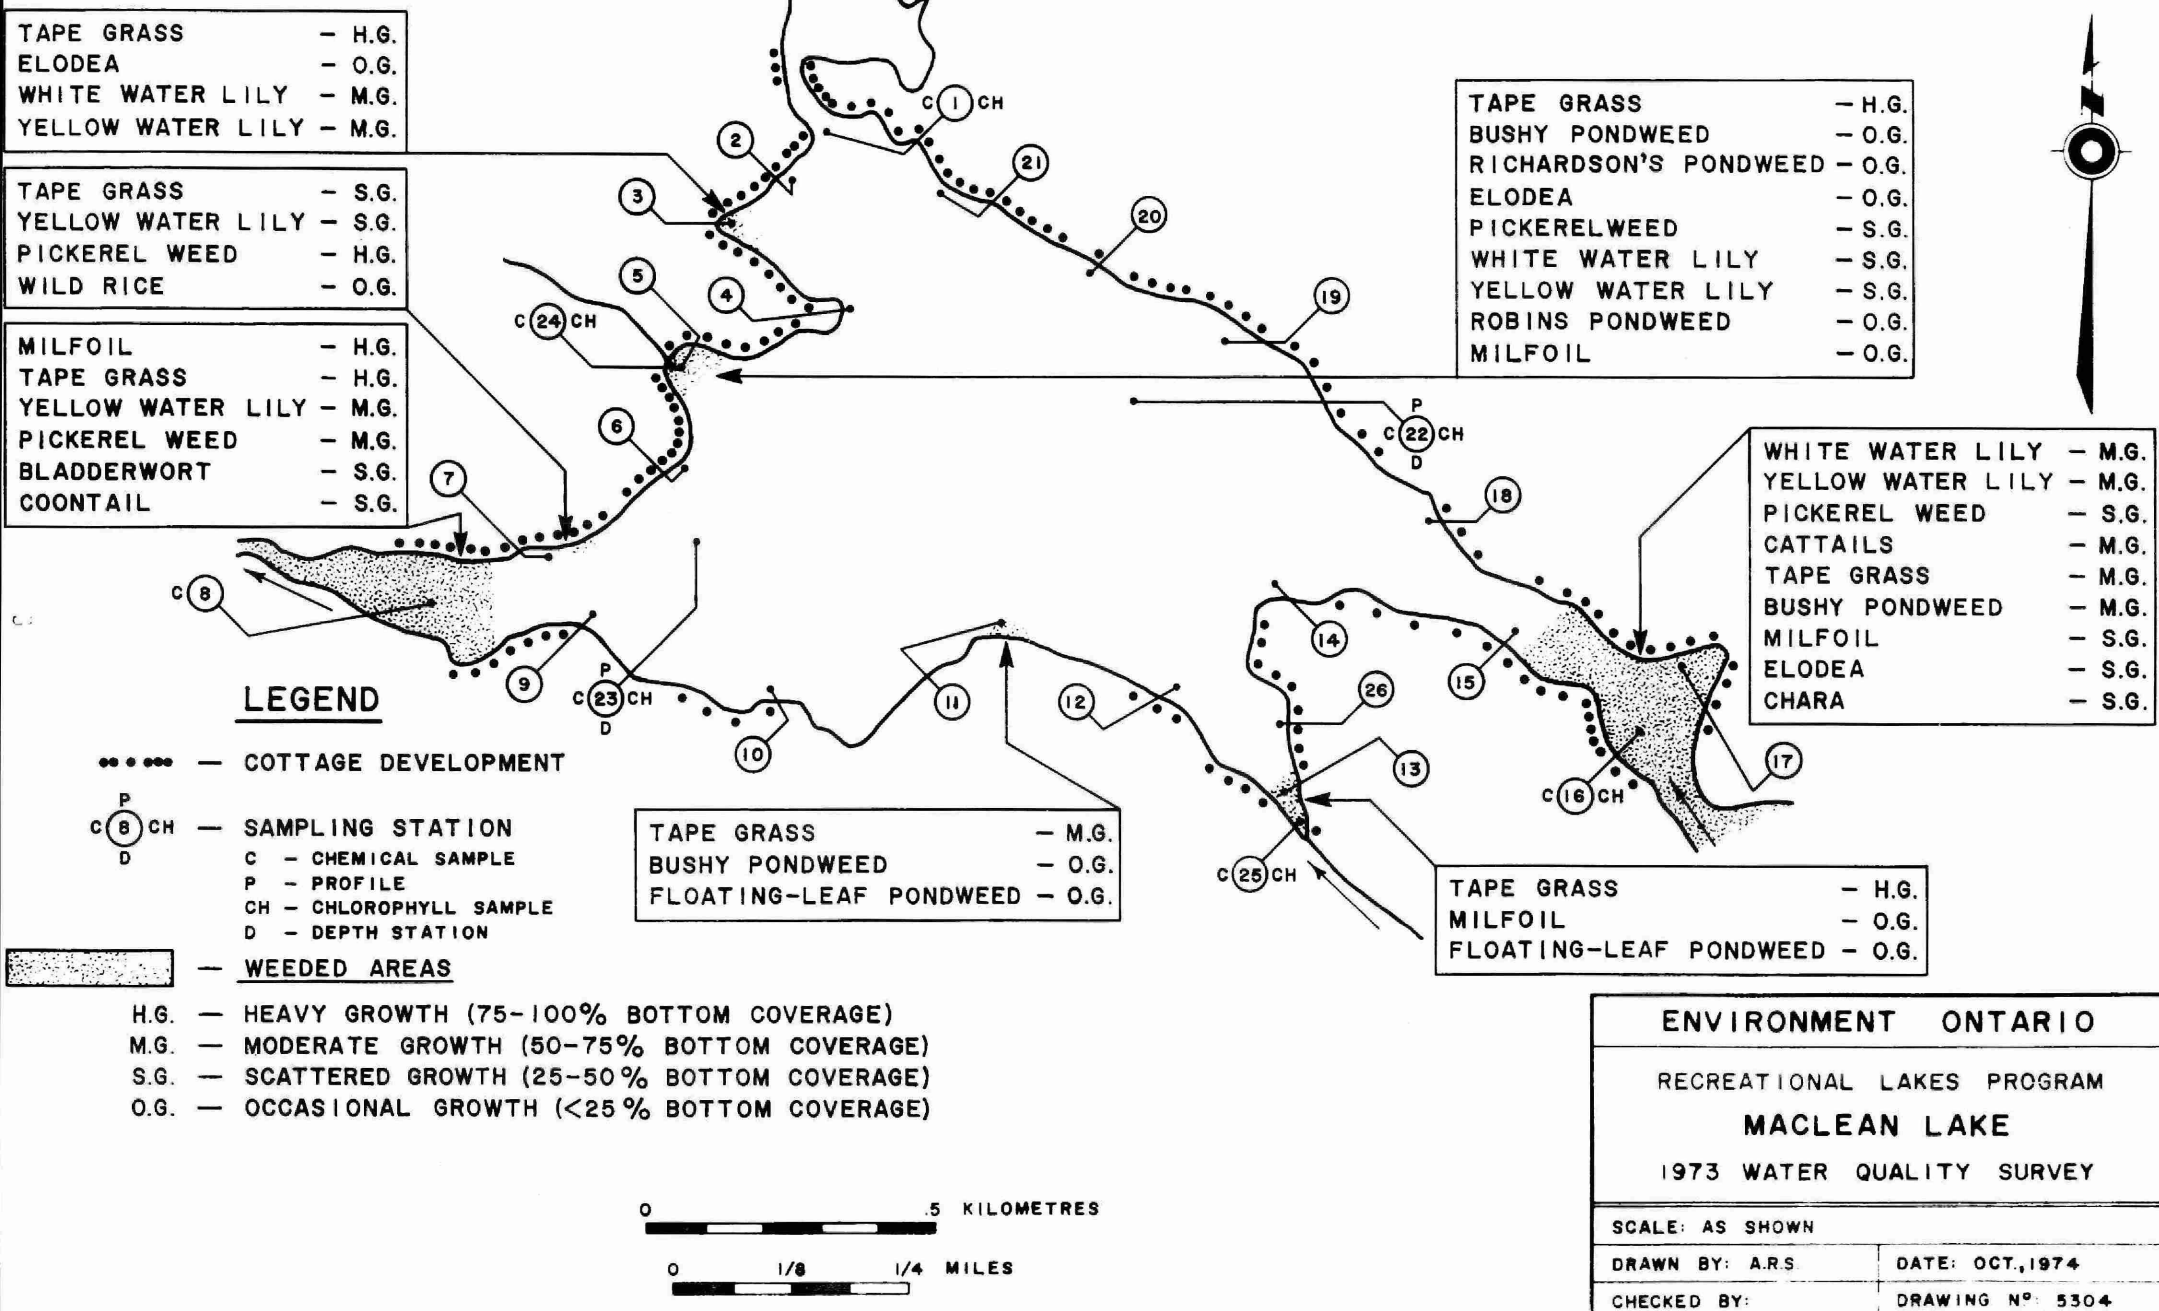
FIGURE 1 - STATION LOCATIONS, LAKESHORE DEVELOPMENT AND MAJOR AREAS OF SHORELINE AQUATIC PLANT GROWTH OF MACLEAN LAKE

Samples for bacterial analysis were taken daily one meter below the surface at 26 stations established throughout the lake, as well as from one meter above the bottom at two mid-lake stations (Figure 1).

There are approximately 150 cottages on MacLean Lake (Figure 1). The lake is heavily developed, with the exception of a relatively large undeveloped area along the southwest shoreline. The lake is serviced by one marina and a government dock at the west end of the lake.

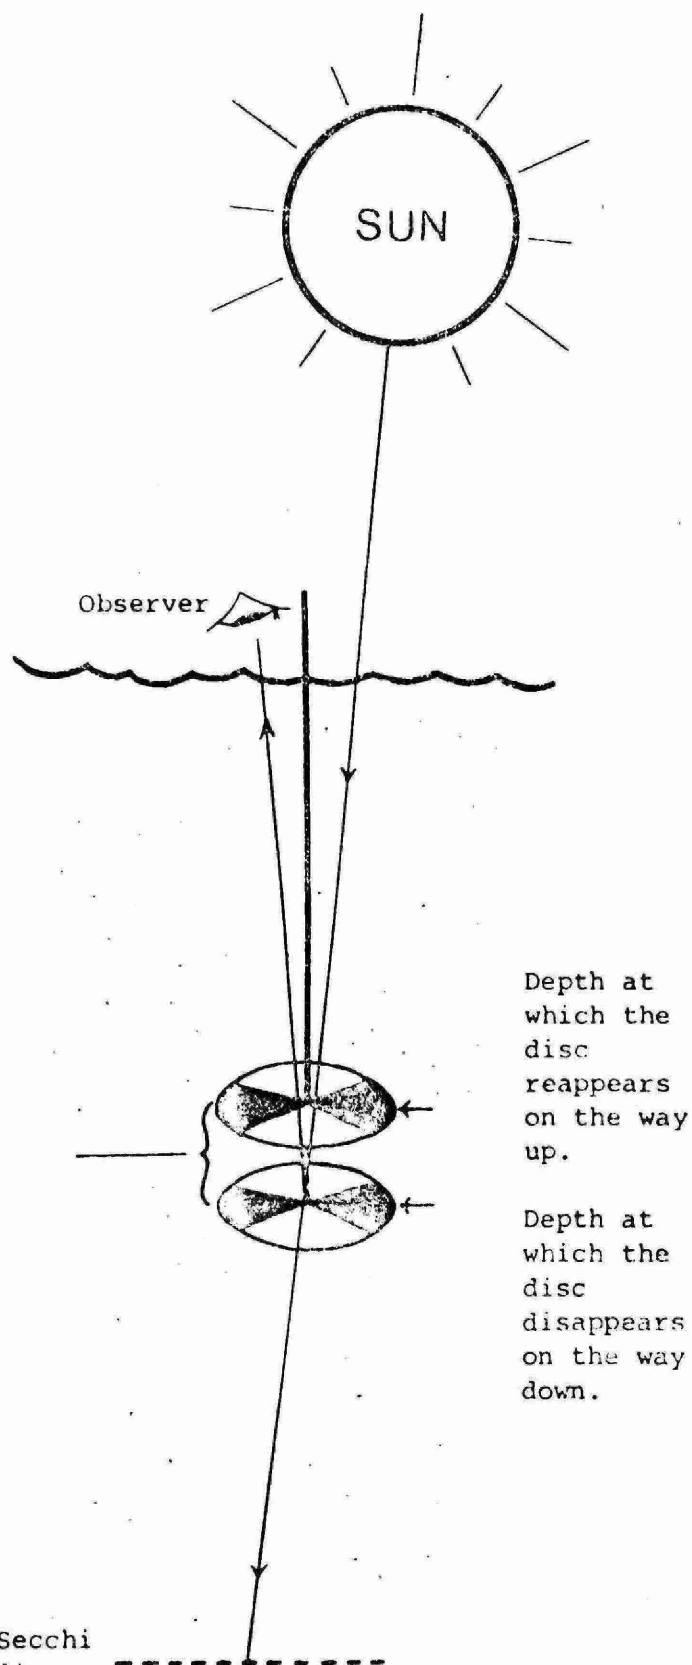
FIGURE 2: USE OF THE SECCHI DISC TO DETERMINE WATER CLARITY.

The "Secchi Disc Reading" is obtained by averaging the depth at which a 23cm (9") dia. black and white plate, lowered into the lake just disappears from view and the depth where it reappears as it is pulled up.

Most of the free-floating algae are suspended in the illuminated region between the lake surface and 2 times the Secchi disc reading.

Clear, algae-free lake:
Secchi disc readings tend to be greater than 3m (9 feet).

Turbid or algae-rich lake:
Secchi disc readings tend to be less than 3m (9 feet).

The variations in temperature and dissolved oxygen values with depth were measured at the two deep water stations with an electronic probe lowered into the lake and water clarity was measured with a Secchi disc (Figure 2). The pH of the samples was also measured in the field.

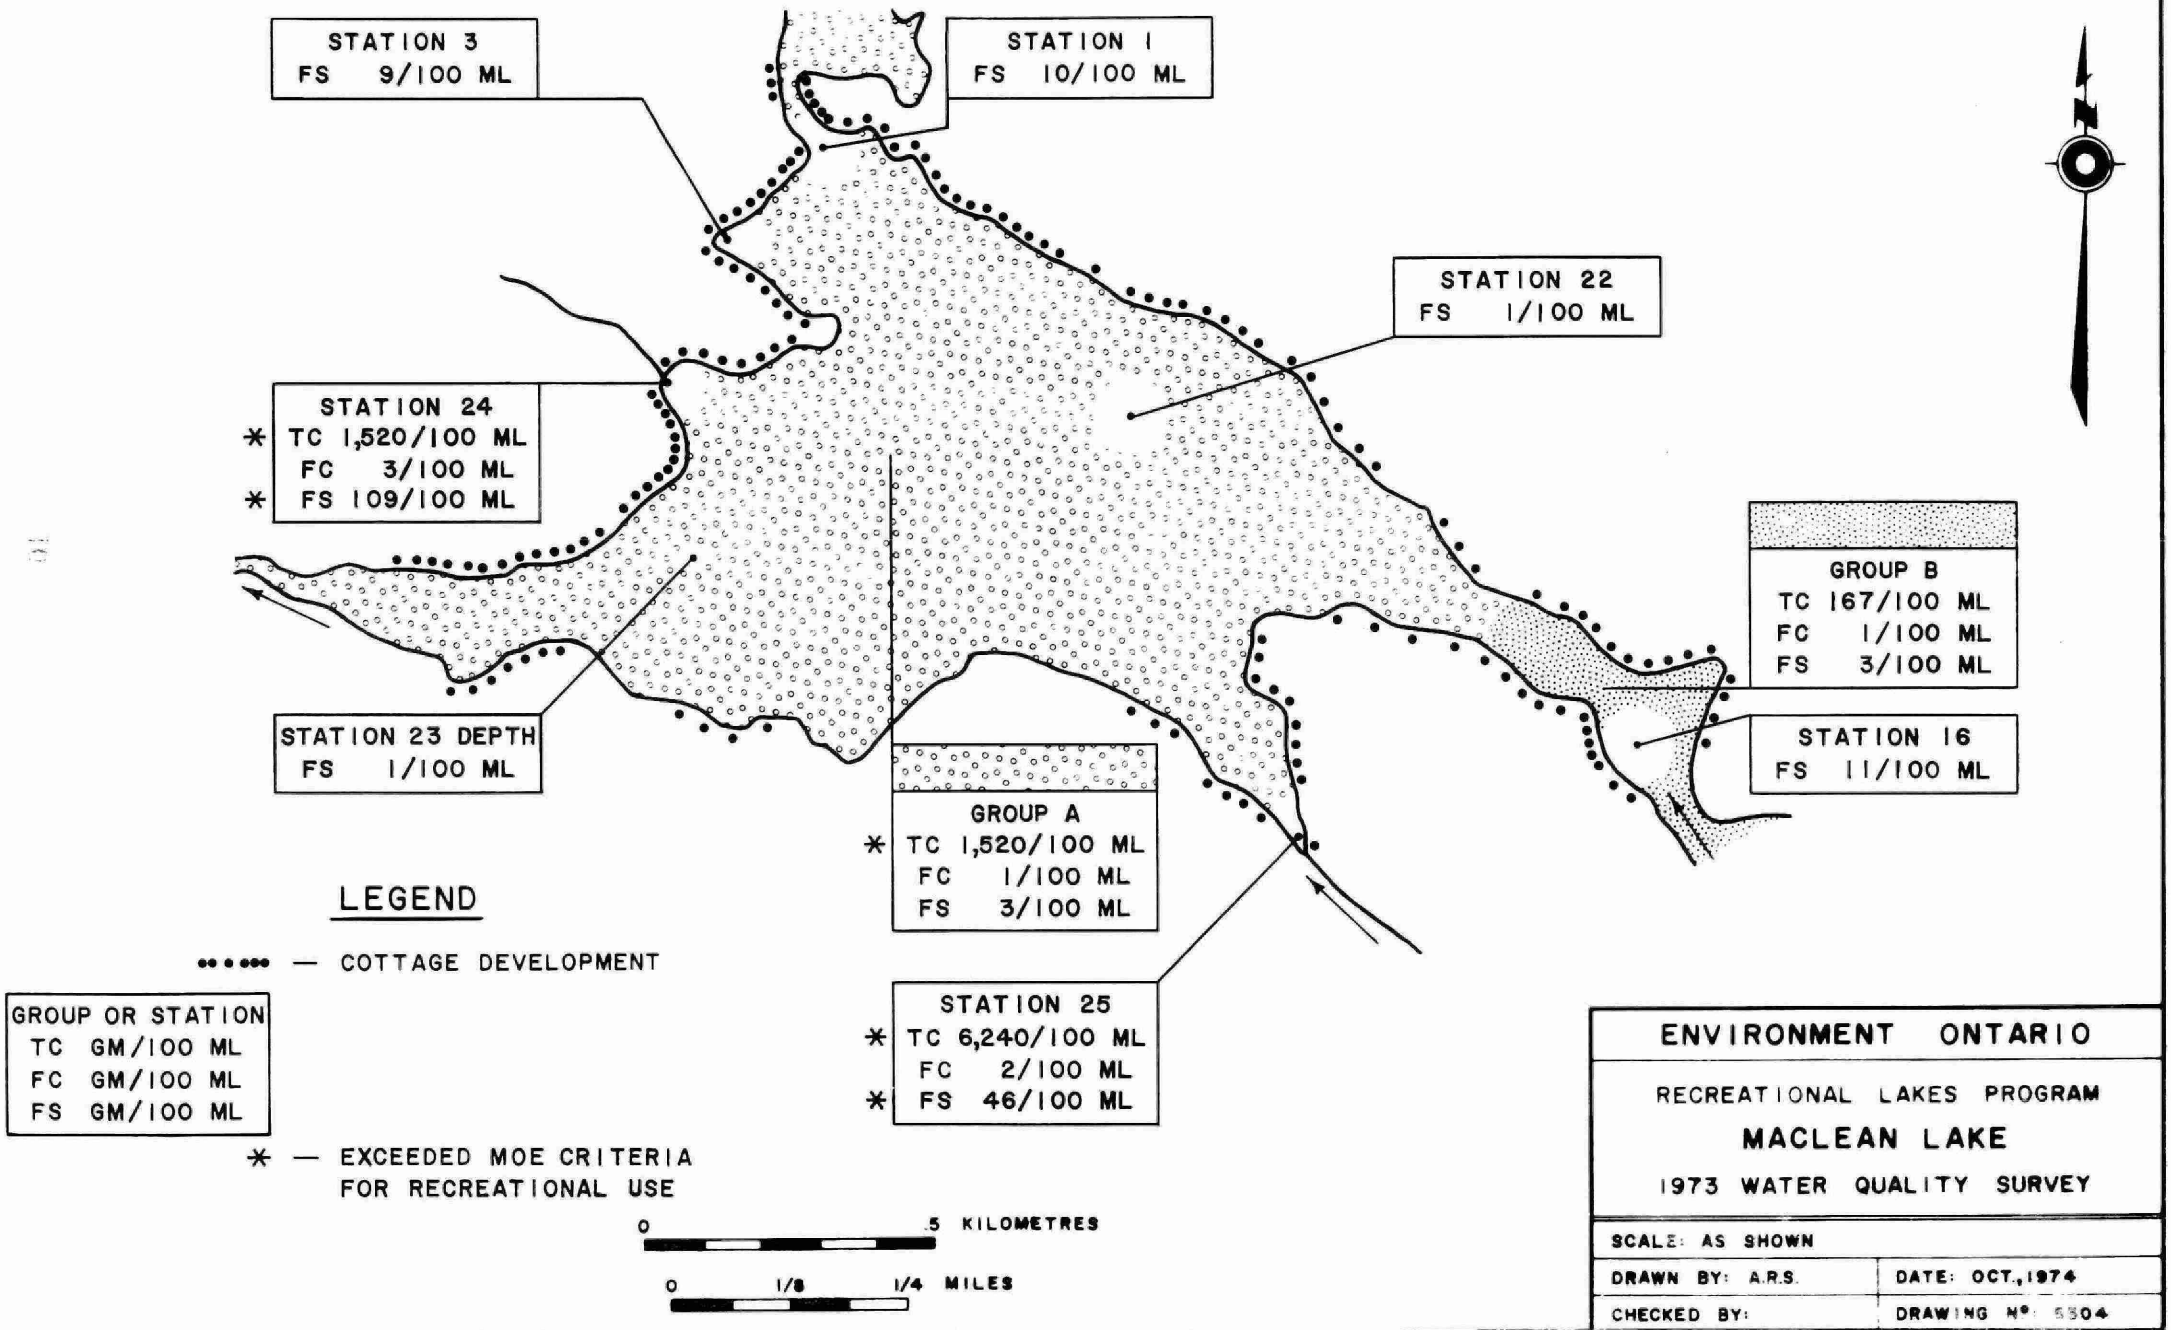
FIGURE 3 - DISTRIBUTION OF BACTERIA DURING THE JUNE SURVEY

The June survey however, indicated that total coliform densities exceeded the criteria for most of the lake, but were not accompanied by corresponding increases in the levels of fecal coliform and enterococcus bacteria. At this time, the main body of MacLean Lake (Group A; Figure 3) had a high geometric mean of 1,520 TC/100 ml, while the combined inflow from Otter Lake and the Matchedash River (Group B), contained only 167 TC/100 ml (Figure 3). Fecal coliforms and fecal streptococcus levels were 1 FC/100 ml and 3 FS/100 ml, except at Stations 24 and 25. The small inflow in a bay in the southern portion of MacLean Lake (Station 25) had geometric means of 6,240 TC, 2 FC and 46 FS/100 ml, and the mouth of a small creek in the northwest bay (Station 24) draining a marsh area had a high bacterial level of 1,520 TC, 3 FC and 109 FS/100 ml. Since both of these inflows had only marginally higher fecal coliform levels than were encountered on the rest of the lake, the source of these bacterial inputs is not likely human in origin because of the relatively high fecal streptococcus densities.

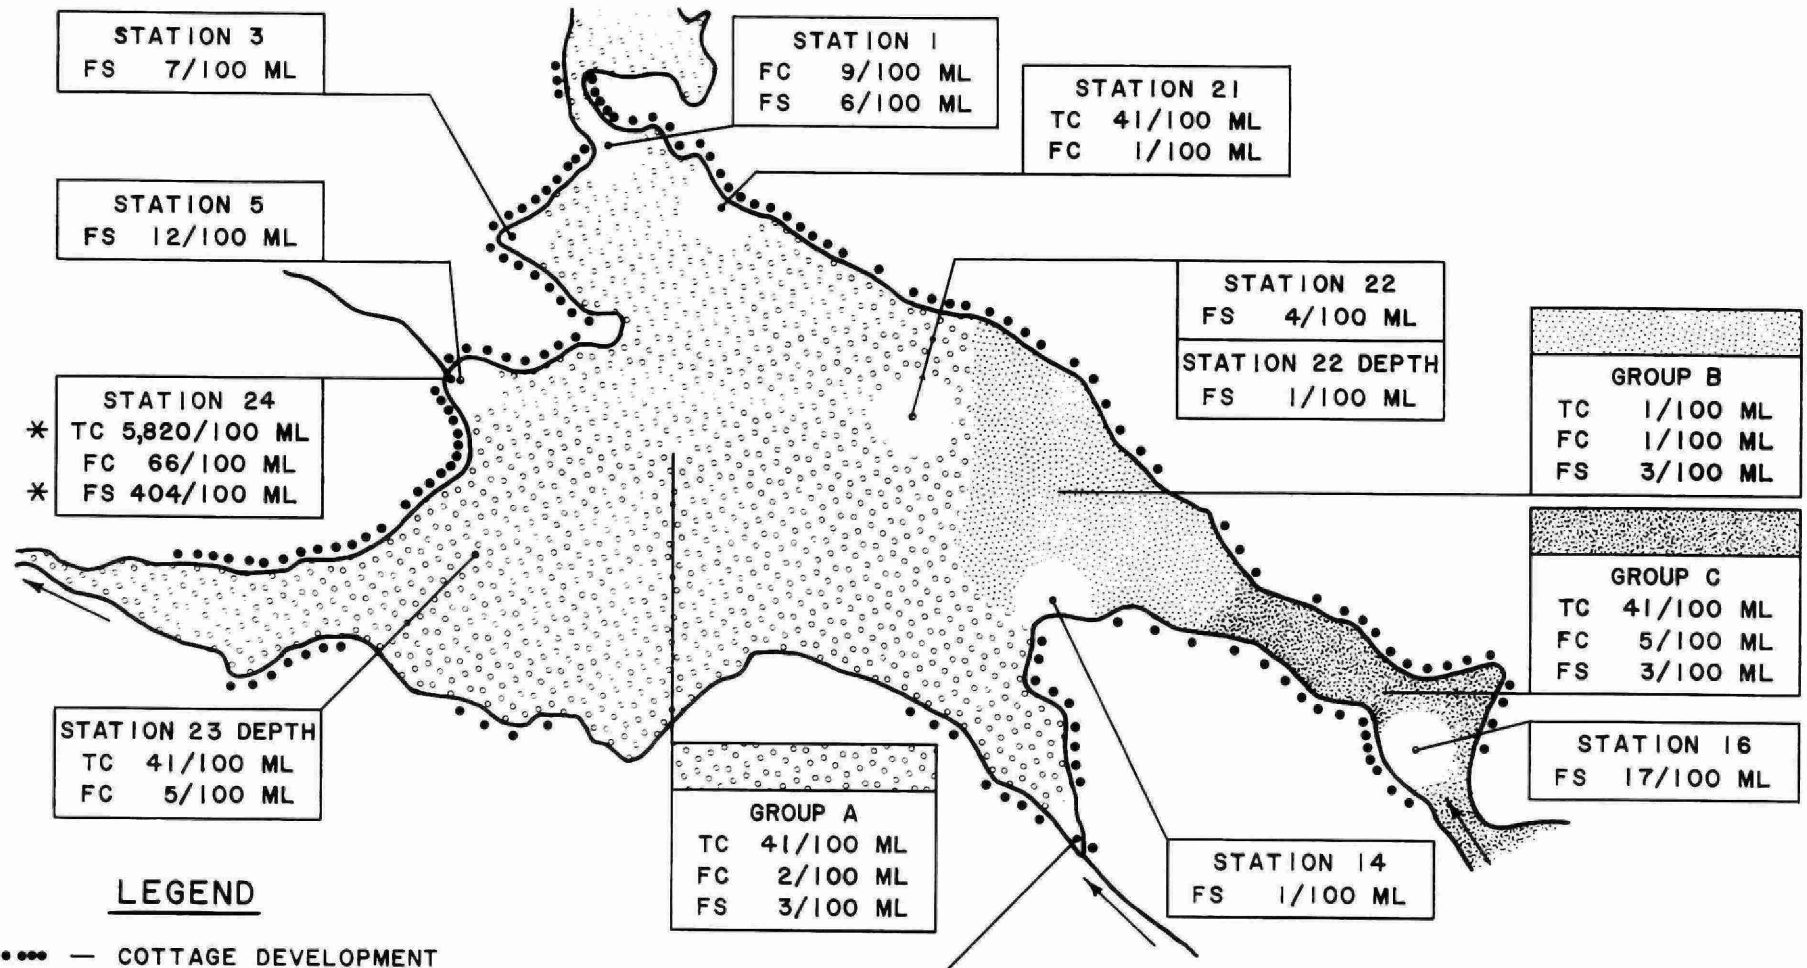
FIGURE 4 - DISTRIBUTION OF BACTERIA DURING THE AUGUST SURVEY

The overall bacteriological water quality of MacLean Lake in August was much improved over that of the immediate June survey. The overall geometric mean for total coliforms had dropped substantially to 41 TC/100 ml (Group A; Figure 4). The fecal coliform geometric mean for the lake was 2 FC/100 ml except for the area within the influence of the Matchedash River (Group C) which was 5 FC/100 ml and an intermediate area (Group B), with 1 FC/100 ml (Figure 4). An inflow in the extreme northerly bay (Station 1) proved to be a minor pollution source with 9 FC and 6 FS/100 ml. The small creek in the northwest bay (Station 24) during August had exceptionally high levels of TC and FS, which were in excess of the Recreational criteria, with geometric means of 5,820 TC and 404 FS/100 ml. The highest fecal coliform levels were also encountered at Station 24 with a mean of 66 FC/100 ml which approached the Recreational criteria.

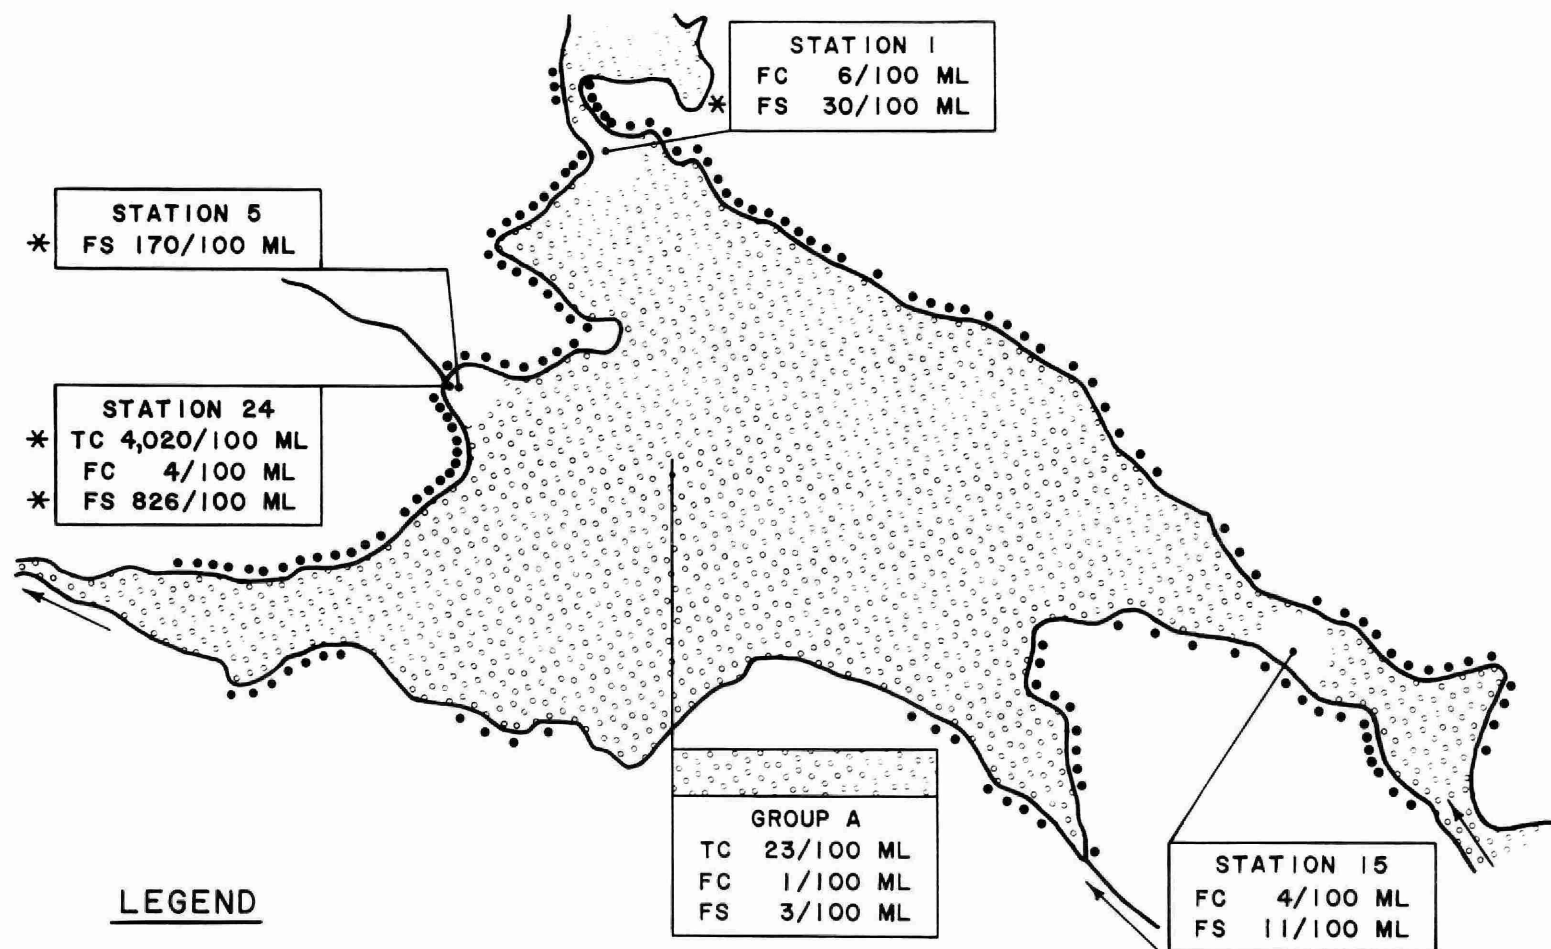
FIGURE 5 - DISTRIBUTION OF BACTERIA DURING THE SEPTEMBER SURVEY

The overall geometric mean for total coliforms was slightly lower (23 TC/100 ml; Figure 5) in September than in August. The only exception noted was the inflow of the small creek in the northwest bay (Station 24) which again had an extremely high geometric mean of 4,020 TC/100 ml. The fecal coliform density for the main body of MacLean Lake in the fall was homogeneous at 1 FC/100 ml. The inflow in the extreme northerly bay (Station 1) had a mean of 6 FC/100 ml, while both a small creek (Station 24), and a cottaged area in the south bay (Station 15), within the influence of the Matchedash River, had means of 4 FC/100 ml.

The overall geometric mean for enterococcus in September was 3 FS/100 ml. Two exceptions were the inflow in the extreme north (Station 1), and the small creek in the northwest bay (Station 24) which both exceeded the criteria with means of 30 FS and 826 FS/100 ml respectively. Furthermore the bay (Station 5) influenced by this small creek (Station 24) had high enterococcus levels of 170 FS/100 ml, which exceeded the Recreational criteria.

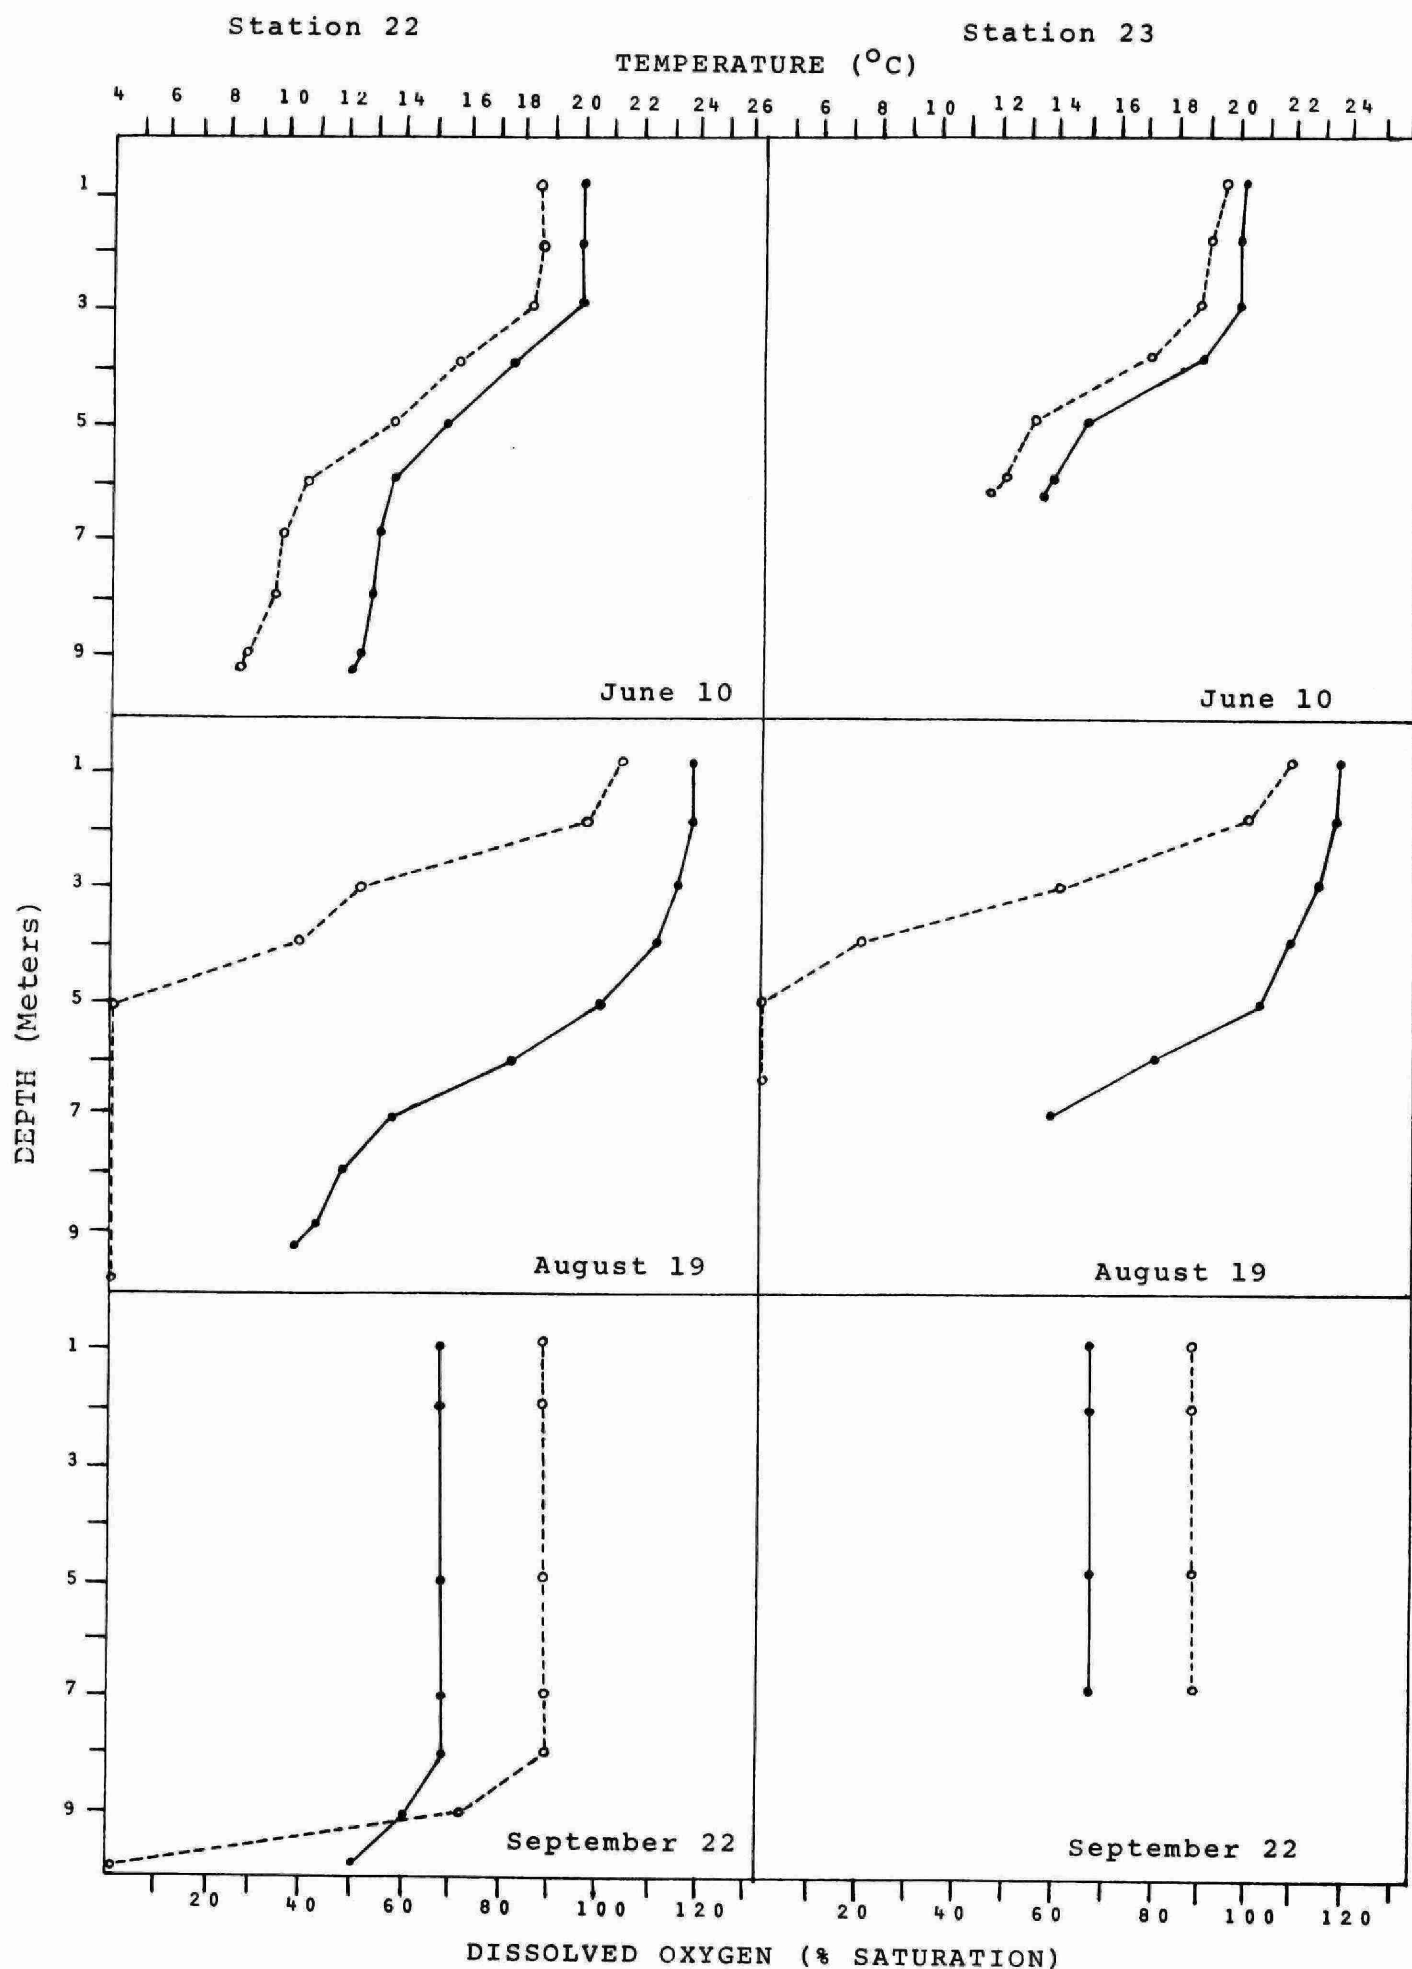
A zone of rapid temperature decline (thermocline) was observed at both deep-water stations in MacLean Lake during the spring and summer surveys. During the fall survey, due to the mixing action of the wind, Station 23 had homothermal (uniform temperature) conditions while Station 22 was nearly homothermal, having a thermocline only in the last 2 meters above bottom (Figure 6). Later fall sampling indicated that the lake completely "turned over" by mid-October (see Page A-6 for explanation).

By the August survey, severe oxygen depletions had occurred in the bottom waters of MacLean Lake, with the waters at the 5 meter depth and below void of dissolved oxygen until the lake mixed in the fall (Figure 6). Even during the later part of the June survey, low dissolved oxygen concentrations were evident in the bottom 3 meters of Station 22, averaging less than 30% saturation, and were as low as 8% saturation at 1 meter off bottom. These dissolved oxygen depletions are caused by biochemical oxidation and bacterial decomposition of organic material, especially algae (see page A-6). Fish and fish food organisms will not survive at such low oxygen concentrations.

Figure 6 : Dissolved oxygen (---) and temperature (—) profiles at Stations 22 and 23 on MacLean Lake.

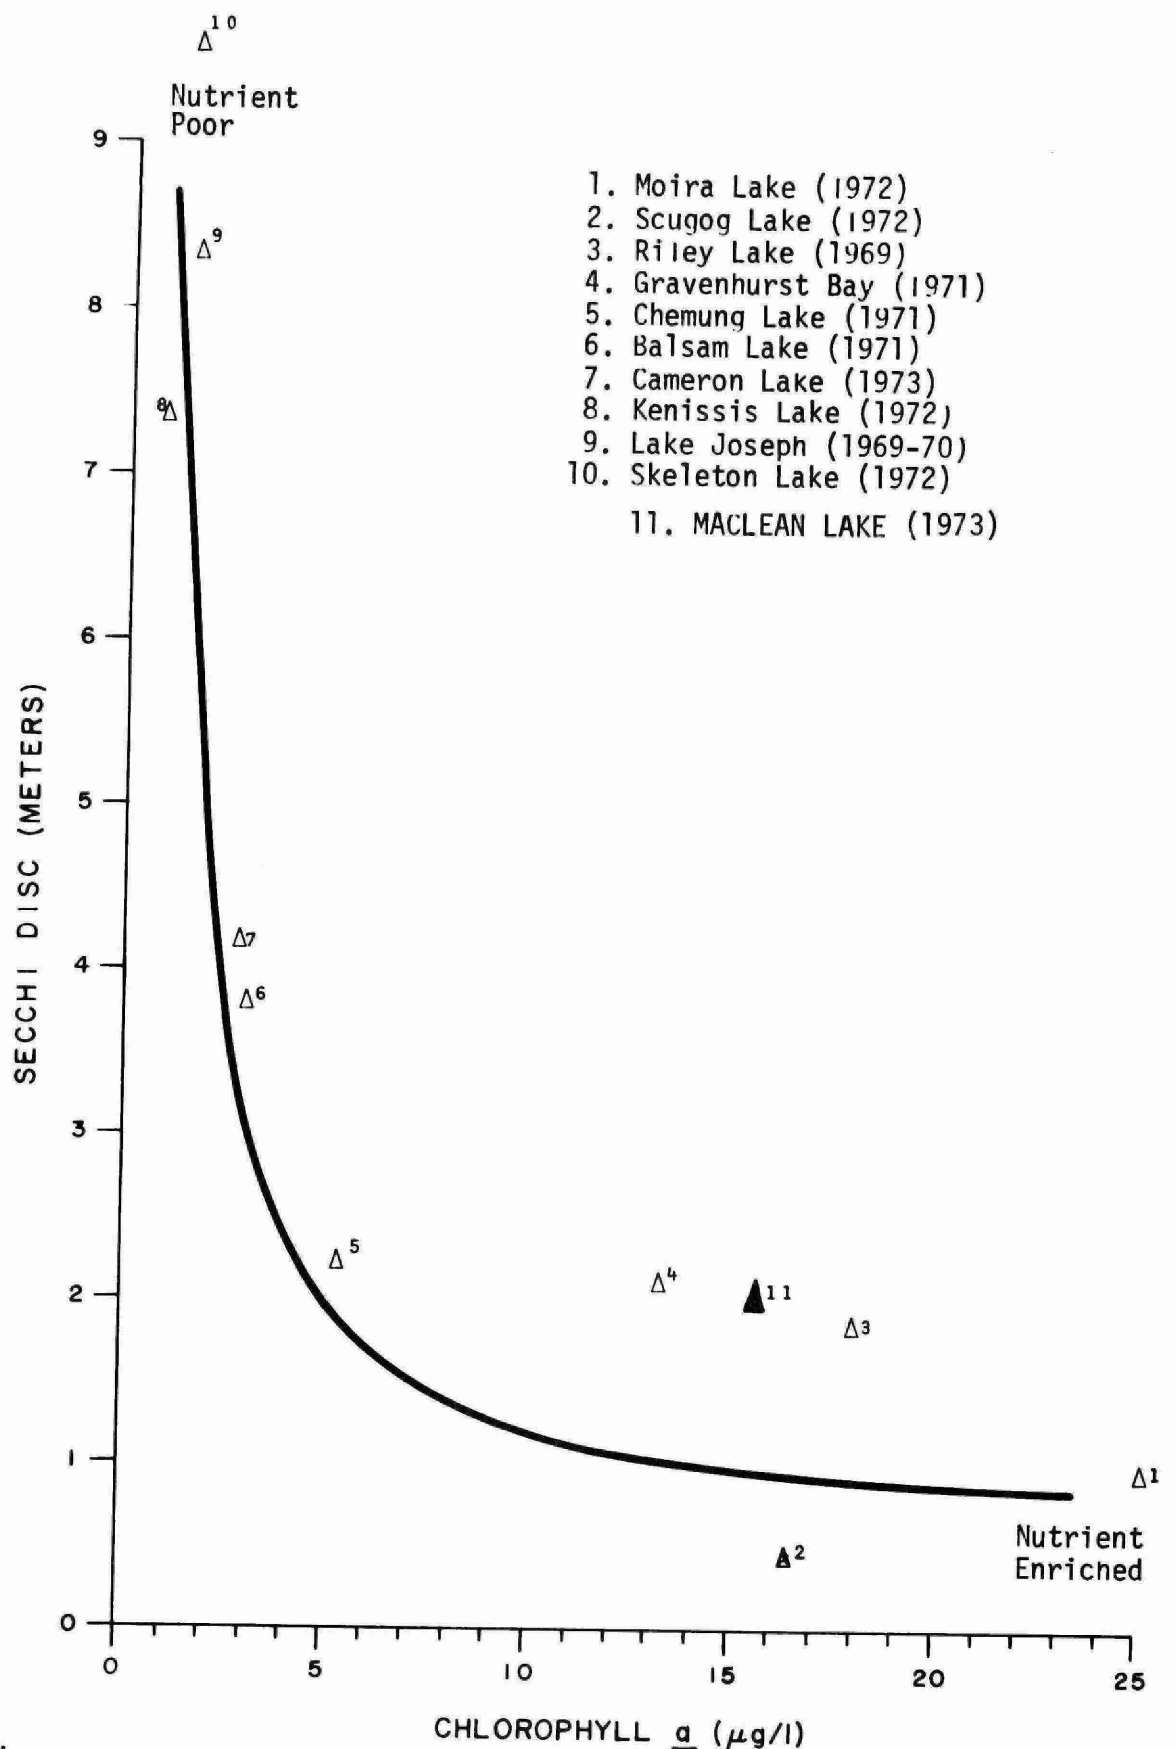
A relationship between chlorophyll a and Secchi disc was derived by Ministry of the Environment Staff, and the status of enrichment of MacLean lake, relative to other well-known lakes, is shown in Figure 7 (see also pA-9). MacLean Lake is similar to Scugog Lake, Riley Lake and Gravenhurst Bay, all of which are highly enriched bodies of water.

Figure 7 : The mean of chlorophyll *a* and Secchi disc measurements in MacLean Lake relative to a curve describing the chlorophyll *a*-Secchi disc relationship in many Ontario lakes. Ten other well-known lakes are included for comparison with MacLean Lake.

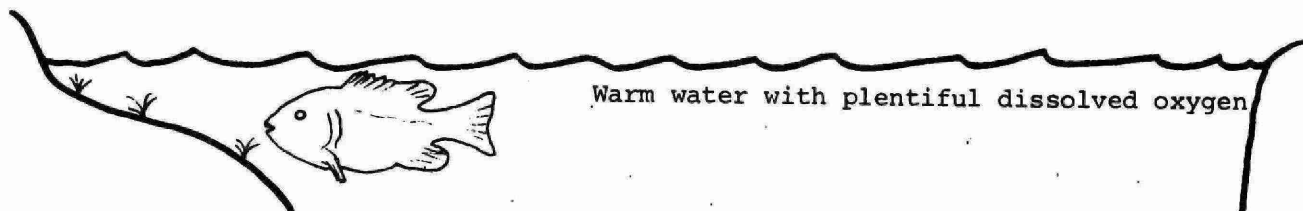
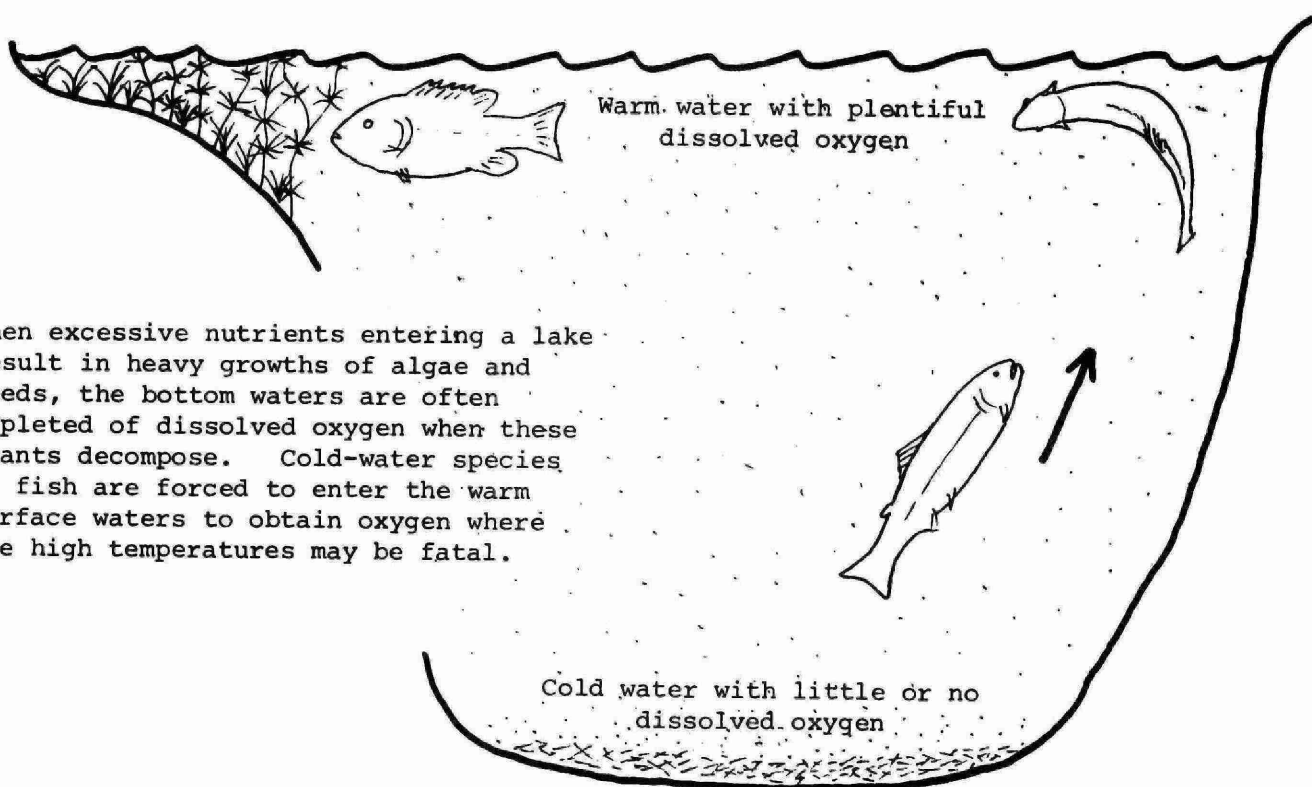
FIGURE A-1: DECOMPOSITION OF PLANT MATTER AT THE LAKE BOTTOM CAN LEAD TO DEATH OF DEEP-WATER FISH SPECIES.

Surface water and shallows are normally inhabited by warm-water fish such as bass, pike and sunfish.

Bottom waters containing plentiful dissolved oxygen are normally inhabited by cold water species such as lake trout and whitefish.

When excessive nutrients entering a lake result in heavy growths of algae and weeds, the bottom waters are often depleted of dissolved oxygen when these plants decompose. Cold-water species of fish are forced to enter the warm surface waters to obtain oxygen where the high temperatures may be fatal.

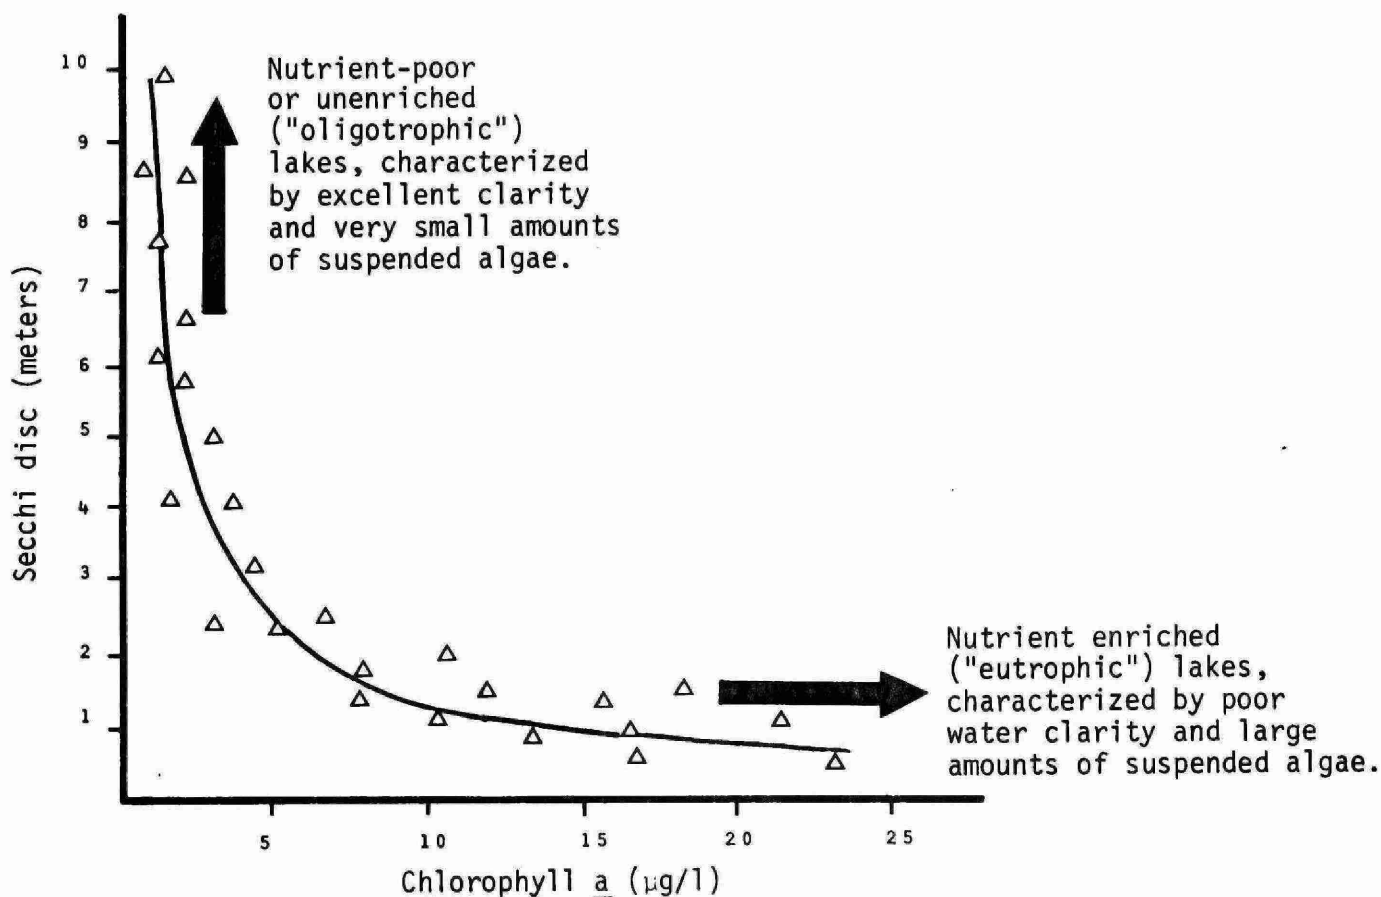
The large amounts of suspended algae which materialize from excessive inputs of nutrients, result in turbid water of poor clarity or transparency. On the other hand, lakes with only small, natural inputs of nutrients and correspondingly low nutrient concentrations (characteristically large and deep lakes) most often support very small amounts of suspended algae and consequently, are clear-water lakes. An indication of the degree of enrichment of lakes can therefore be gained by measuring the density of suspended algae (as indicated by the chlorophyll a concentration - the green pigment in most plants and algae) and water clarity (measured with a Secchi disc). In this regard, staff of the Ministry of the Environment have been collecting chlorophyll a and water clarity data from several lakes in Ontario and have developed a graphical relationship between these parameters which is being used by cottagers to further their understanding of the processes and consequences of nutrient enrichment of Precambrian lakes. The figure on the next page illustrates the above-mentioned relationship.

In the absence of excessive coloured matter (eg. drainage from marshlands), lakes which are very low in nutrients are generally characterized by small amounts of suspended algae (i.e. chlorophyll a) and are clear-water lakes with high Secchi disc values. Such lakes, with chlorophyll a and Secchi disc values lying in the upper left-hand area of the graph are unenriched or nutrient poor ("oligotrophic") in status and do not suffer from the problems associated with excessive inputs of nutrients. In contrast, lakes with high chlorophyll a concentrations and poor clarity are positioned in the lower right-hand area of the graph and are enriched ("eutrophic"). These lakes usually exhibit symptoms of excessive nutrient enrichment including water turbidity owing to large amounts of suspended algae which may float to the surface and accumulate in sheltered areas around docks and bays.

Measurements of suspended algal density (chlorophyll *a*) and water clarity are especially valuable if carried out over several years. Year to year positional changes on the graph can then be assessed to determine whether or not changes in lake water quality are materializing so that remedial measures can be implemented before conditions become critical.
